Evaluation of Copper Pitting in Plainview New York

Prepared for:

Stephen Moriarty, P.E.
Superintendent, Plainview Water District
10 Manetto Hill Road
Plainview, NY 11803

November 13, 2017

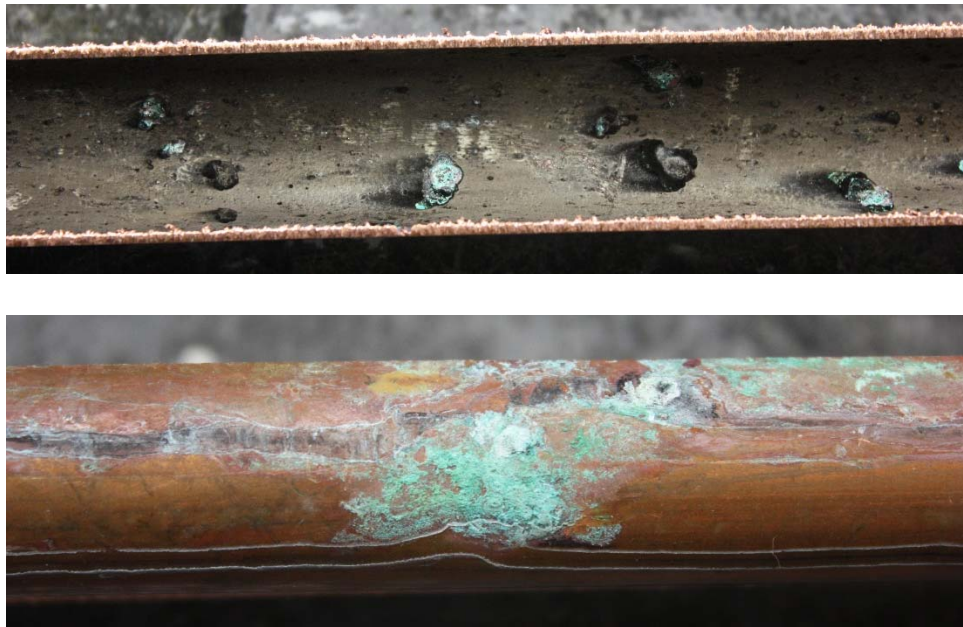
Figure A.1 – Pipe #1 interior surface (top) and exterior surface (bottom)

Representative photographs of the interior and exterior surfaces of five copper pipes are shown in Appendix 1, **Figures A1.1-A1.5**. Each pipe evaluated had non-homogeneous pitting on the

interior surfaces and some outer surface corrosion due to water escaping through the pinhole leaks. The sulfide ‘spot test’ on several of the pits in Pipe #1 did not show any evidence of sulfide.
